SHOREHAM UNIVERSALIST CHURCH ADAPTIVE REUSE

HP 204 DEVELOPMENT ECONOMICS

DANIELLE ALLEN
KRISTI BODINE
TIMOTHY HENDERSON
SAMANTHA JOHNSON

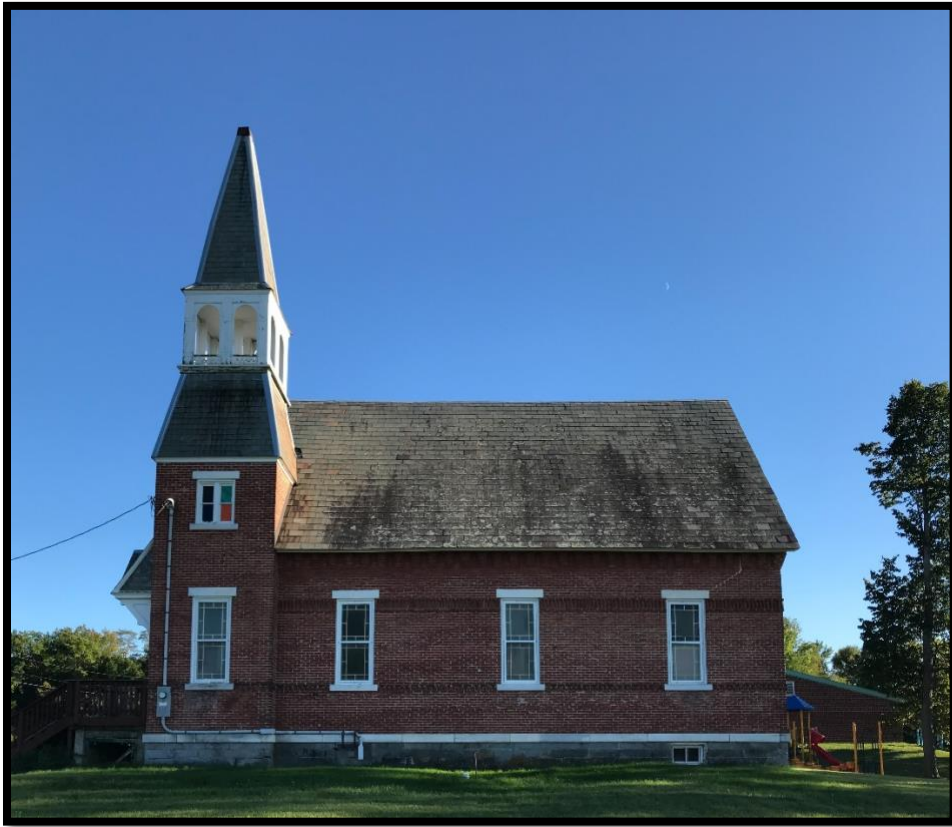
Figure 3: View of the south wall of the 1885 Shoreham Universalist Church. Danielle Allen, 2018.

Built in 1885, the former Shoreham Universalist Church is a 1½ story, veneer brick and timber-frame building that appears to be in good overall condition (Figure 1). The simple asymmetrical design is enhanced by several modest Queen Anne-style features. The roof and tower are covered in gray slate and includes a decorative chimney made of corbelled bricks. The building is visually attractive from the street and features several colorful stained-glass windows in the towers and throughout the body of the building. The large semi-circular window in the front bay of the church is especially striking. The asymmetrical tower and steeple lend the building a sense of monumentality, while the simple stone lintels and sills, along with the brick string course help the building stretch with the surrounding landscape. The church is surrounded on all sides by a sloping lawn.

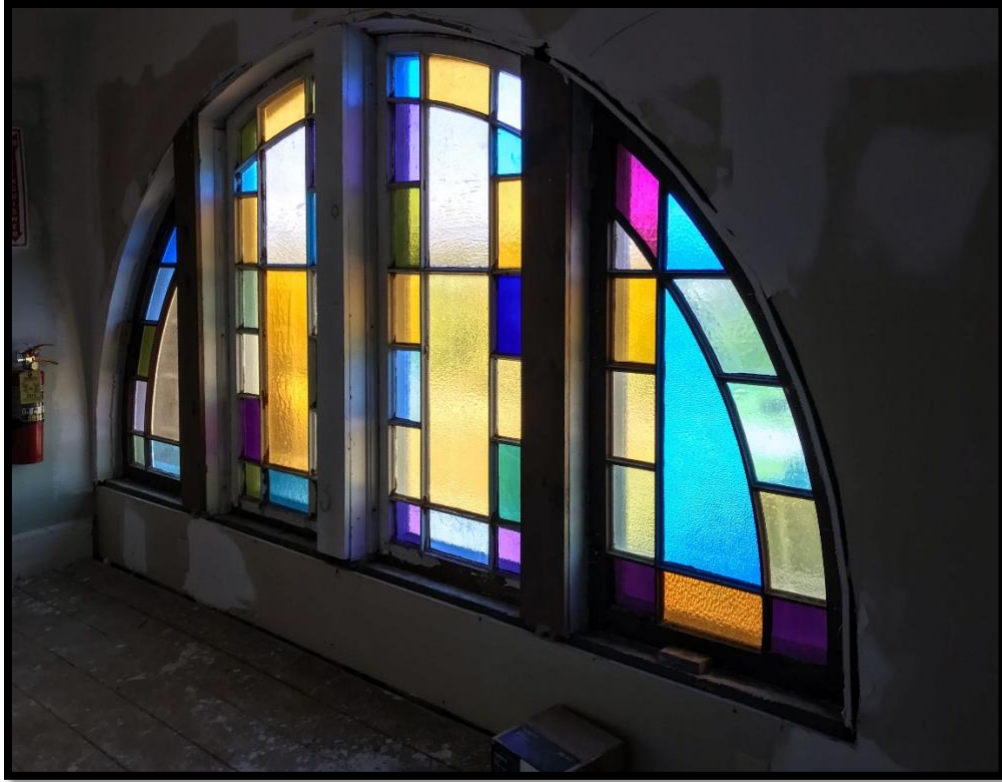
Figure 4: Interior view of the large semi-circular stained-glass window. Danielle Allen, 2018.

The second floor or attic space is very limited but is clean and appears to be in good condition. The space consists of a landing space enclosed by a wooden handrail. This space is accessible by a curved internal staircase that begins in the entrance hall. It is lit by the large semi-circular stained-glass window featured prominently on the eastern wall of the church. leads to the access area for the bell tower.

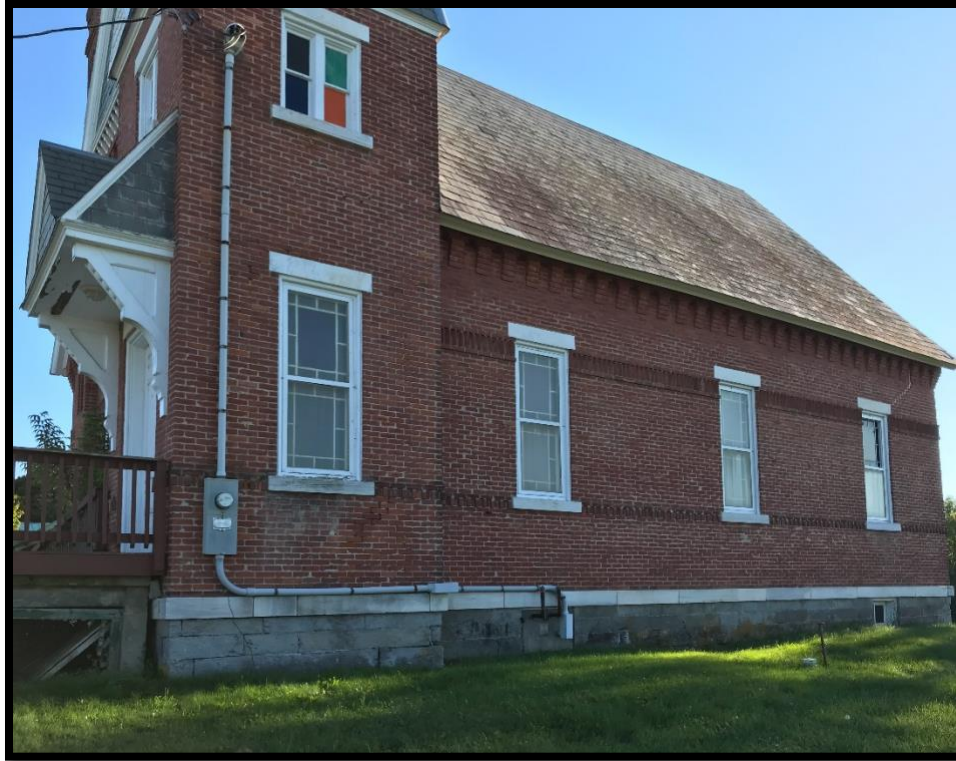
Figure 5: View of the southeastern corner of Shoreham Universalist Church demonstrating the current conditions of the foundation. Danielle Allen, 2018.

The foundation of the building rests approximately 5' below grade and is made of large cut stone blocks (Figure 3). The foundation shows some evidence of dirt and splash back, but these effects could be mitigated through regular cleaning. The stones and the mortar between them appear to be in good condition. The windows housed within the foundation are in fair condition and appear to only need minor repairs to correct deteriorated paint. The area surrounding the foundation is appropriately cleared of vegetation and properly sloped to mitigate the effects of storm water drainage.

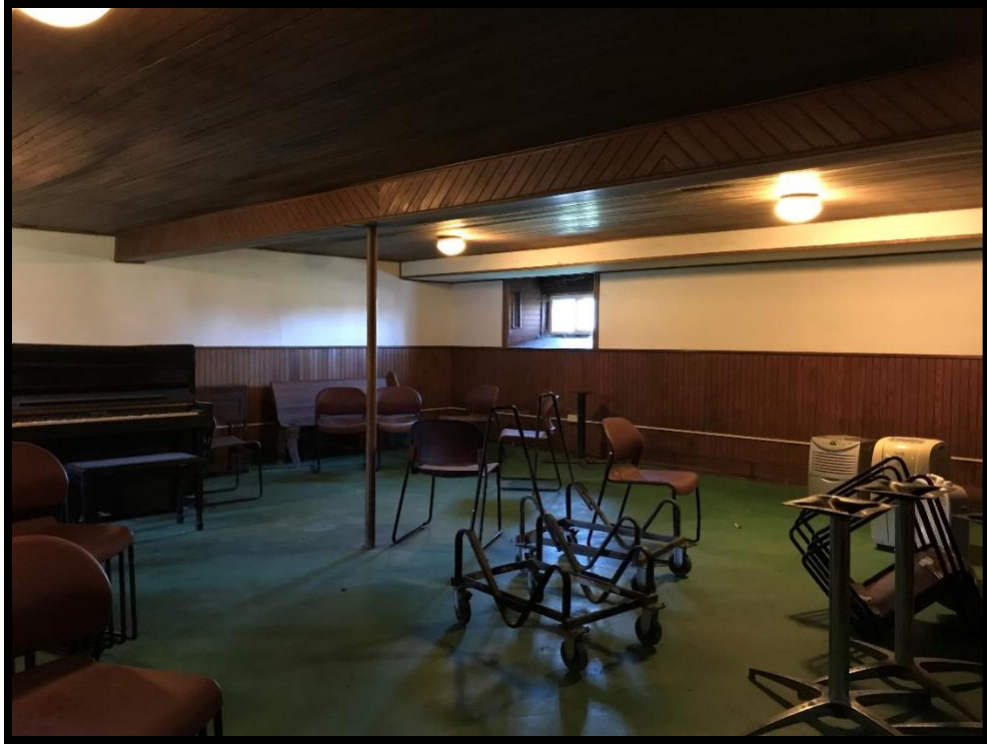
Figure 6: View of the current conditions and orientation of the features in the basement of the church. Danielle Allen, 2018.

The basement is a semi-submerged space with windows lighting the north and south walls (Figure 4). The space is lit by four sliding windows, housed within the building's foundation. This space has a tile floor, wood-paneled wainscoting and a wood paneled ceiling. The basement is supported internally by regularly placed structural columns but is otherwise an open space. In addition to the open space, the basement also currently features a small bathroom, kitchenette, and the furnace. These utilities are separated from the open space in a semi-enclosed area on the eastern portion of the basement. This area can be accessed internally through a wooden stair connected to the entrance hall and also externally, through a modern exit on the north wall. Proposed alterations for the adaptive reuse project will enlarge this space, make it more accessible and add bathrooms.

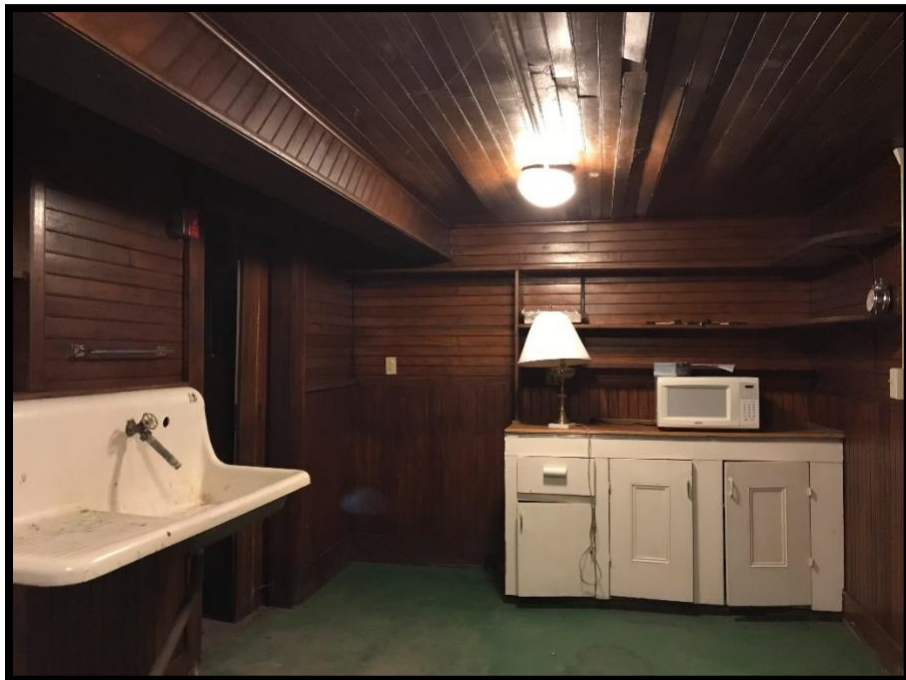
Figure 7: Kitchenette with access to the utility areas for the furnace and the bathroom currently in the basement of the church. Danielle Allen, 2018.

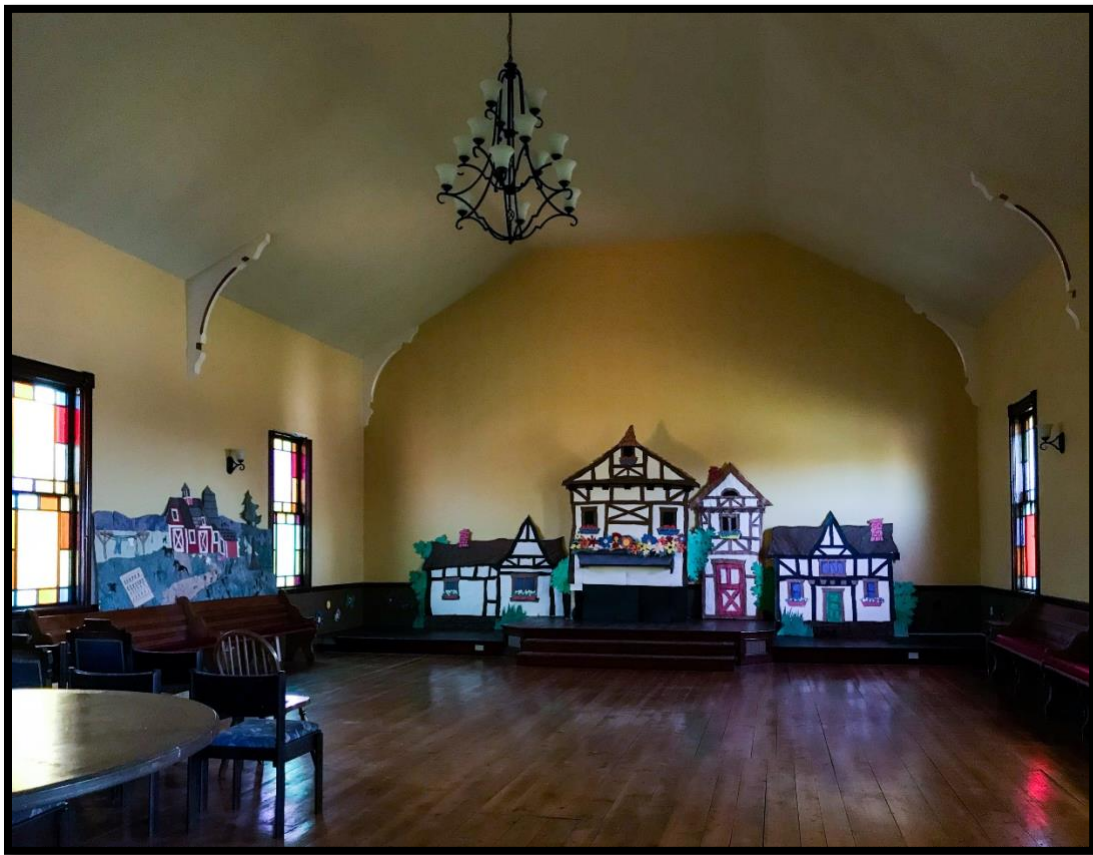
Figure 8: Sanctuary space on the first floor of the church. Danielle Allen, 2018.

The first floor of the building is elevated approximately 3' above grade and is made up of an entrance hall and a large sanctuary space (Figure 6). The entrance hall is lit by a series of colorful stained-glass windows and holds many character defining features including the windows, custom woodwork, original hardware and original light fixtures (Figure 7 – 8). The main sanctuary space is a large vaulted space, regularly lit by a series of stained-glass windows and a prominent central chandelier. The space has been well maintained and remains in good condition. The floors are made from wooden planks that appear to be in good condition. The ceiling is accentuated by decorative brackets and the wall features a wood paneled wainscoting. The sanctuary still retains an elevated stage area along the western wall. Proposed alterations will make this space more accessible and add bathrooms as well as a LULA.

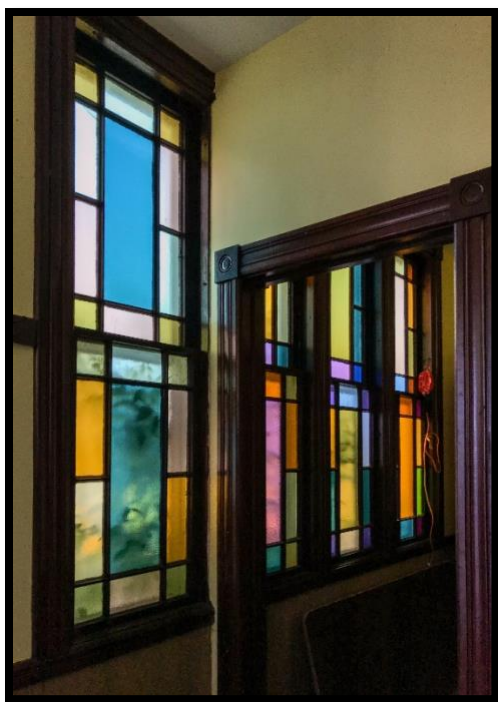
Figure 9: Stained-glass windows and custom woodwork in the entrance hall. Danielle Allen, 2018.

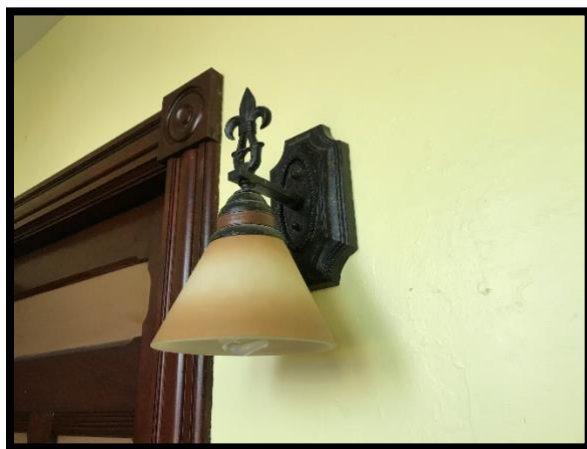
Figure 10: Original light fixture located in the entrance hall. Danielle Allen, 2018.

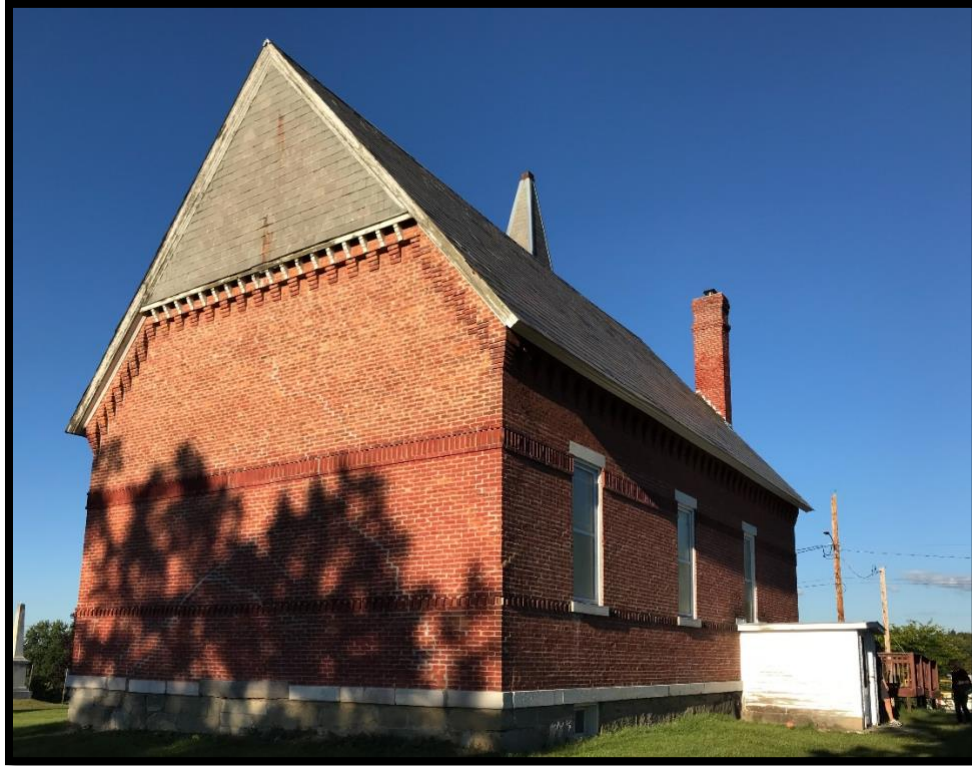
Figure 11: View of exterior western wall, the site of proposed alterations for adaptive reuse of the building. Danielle Allen, 2018.

1. Re-point the chimney and replace the base flashing.
2. Woodwork repairs, including re-orienting the ADA accessible entrance ramp.
3. Conducting a structural review of the masonry on the western wall to prepare for addition (Figure 9).

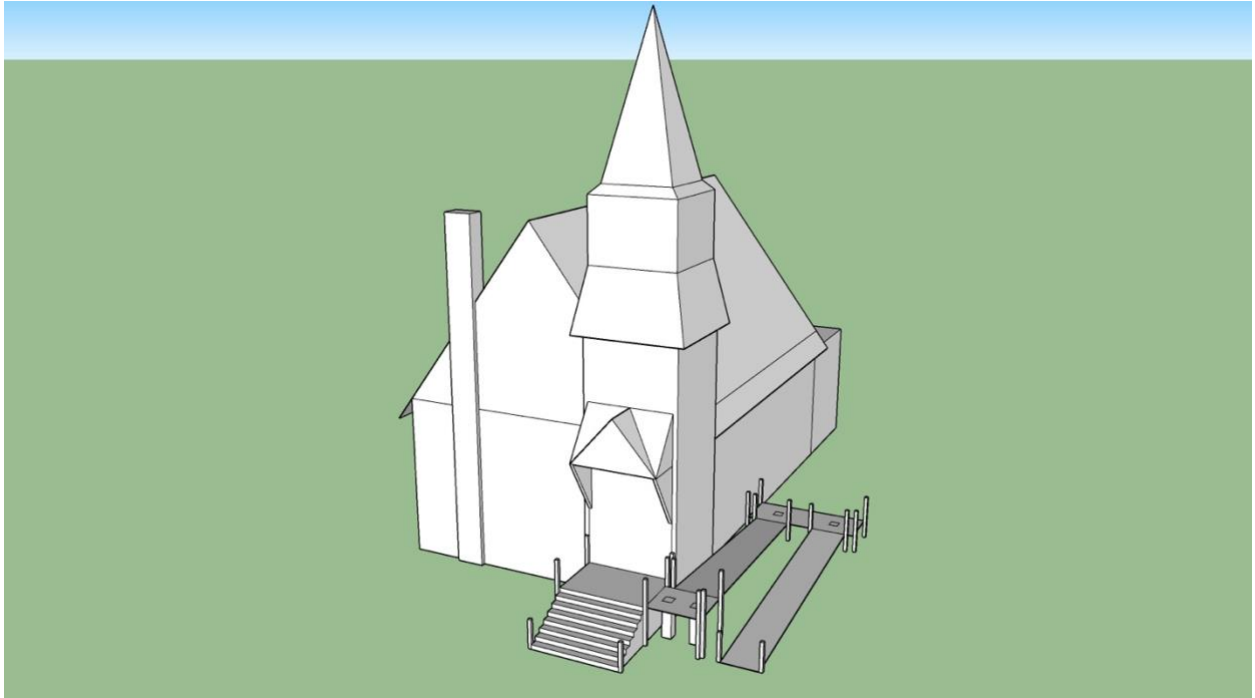
Figure 14: View of exterior renovations from the northeast.

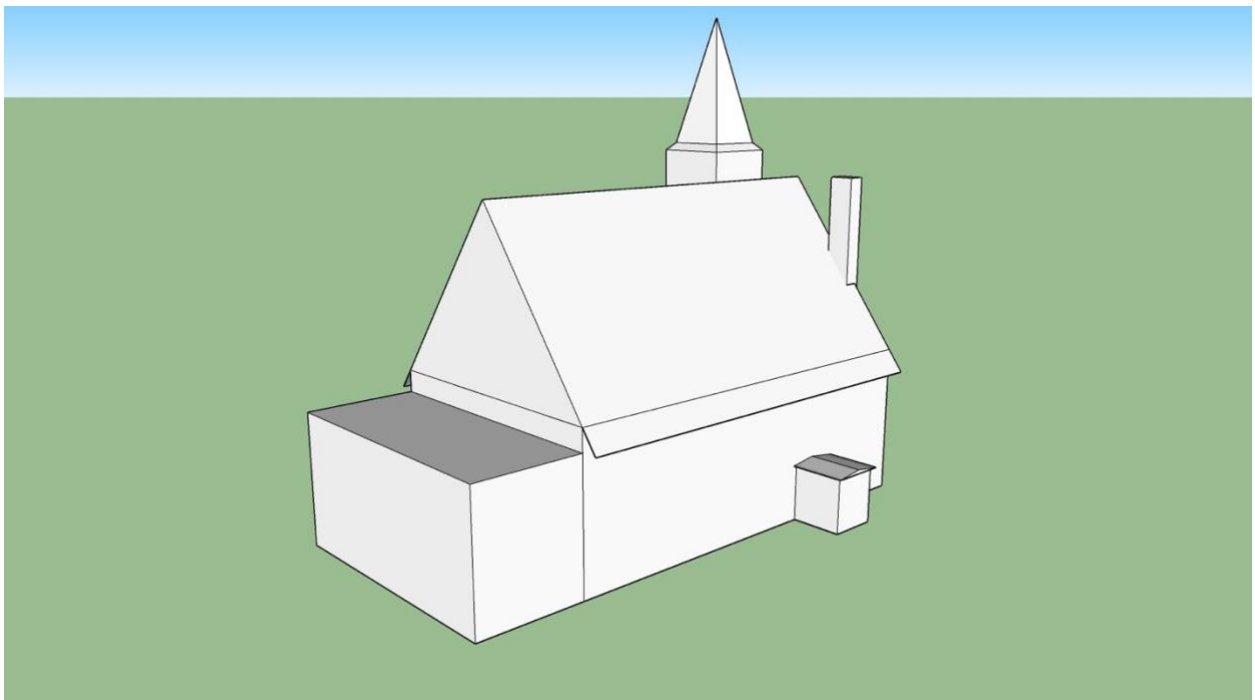
Figure 15: View of proposed exterior renovations from the southwest.

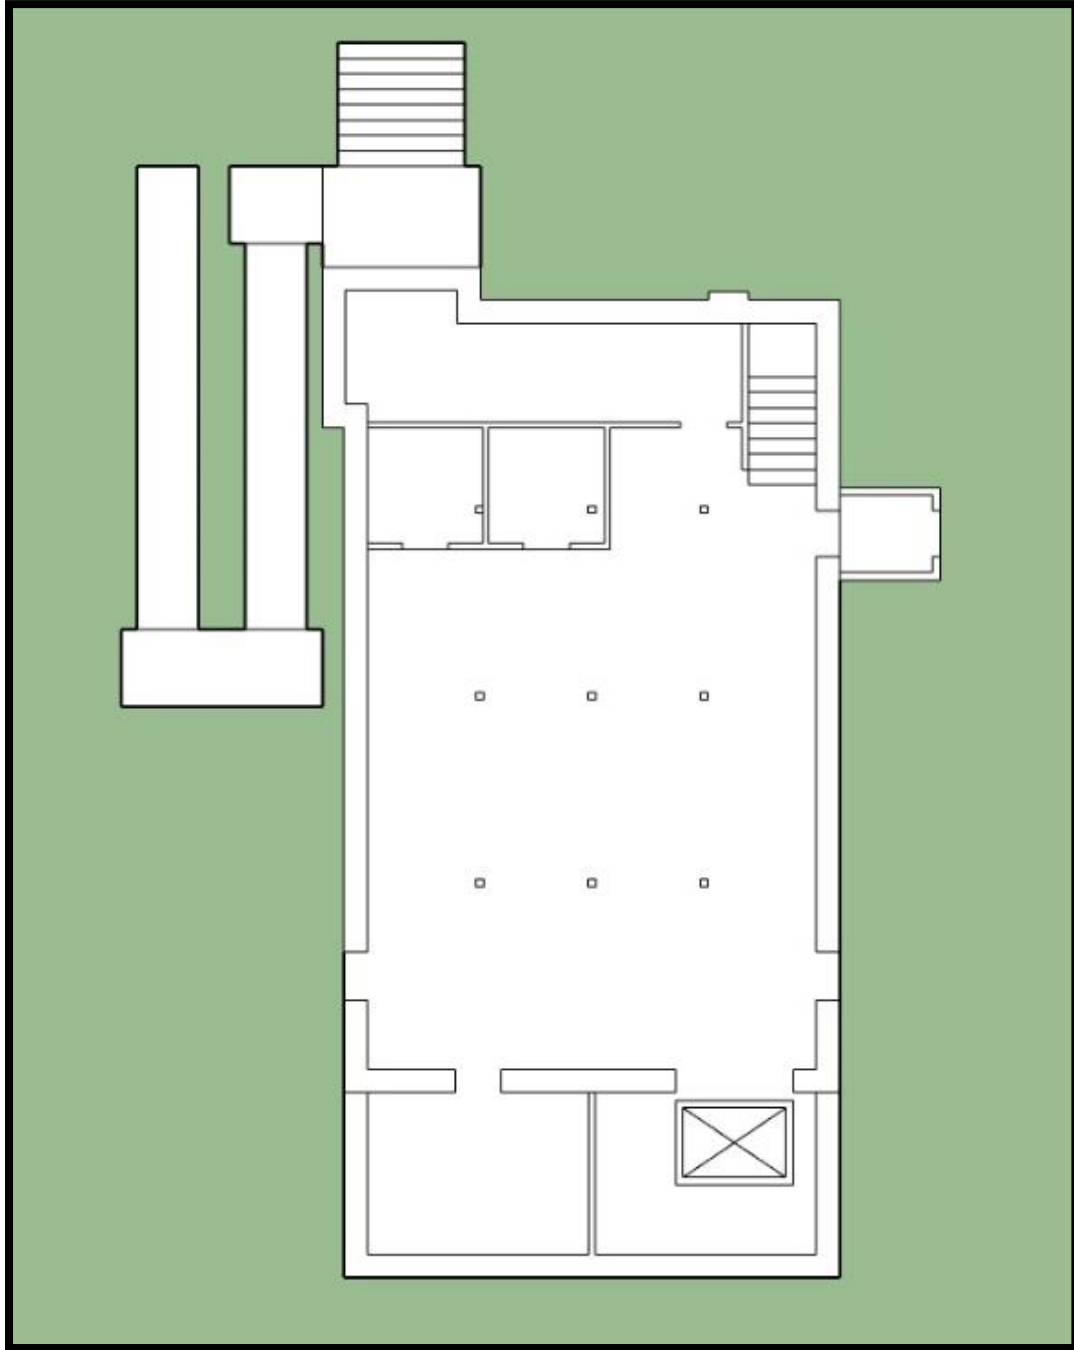
Option 1 – Gathering Space

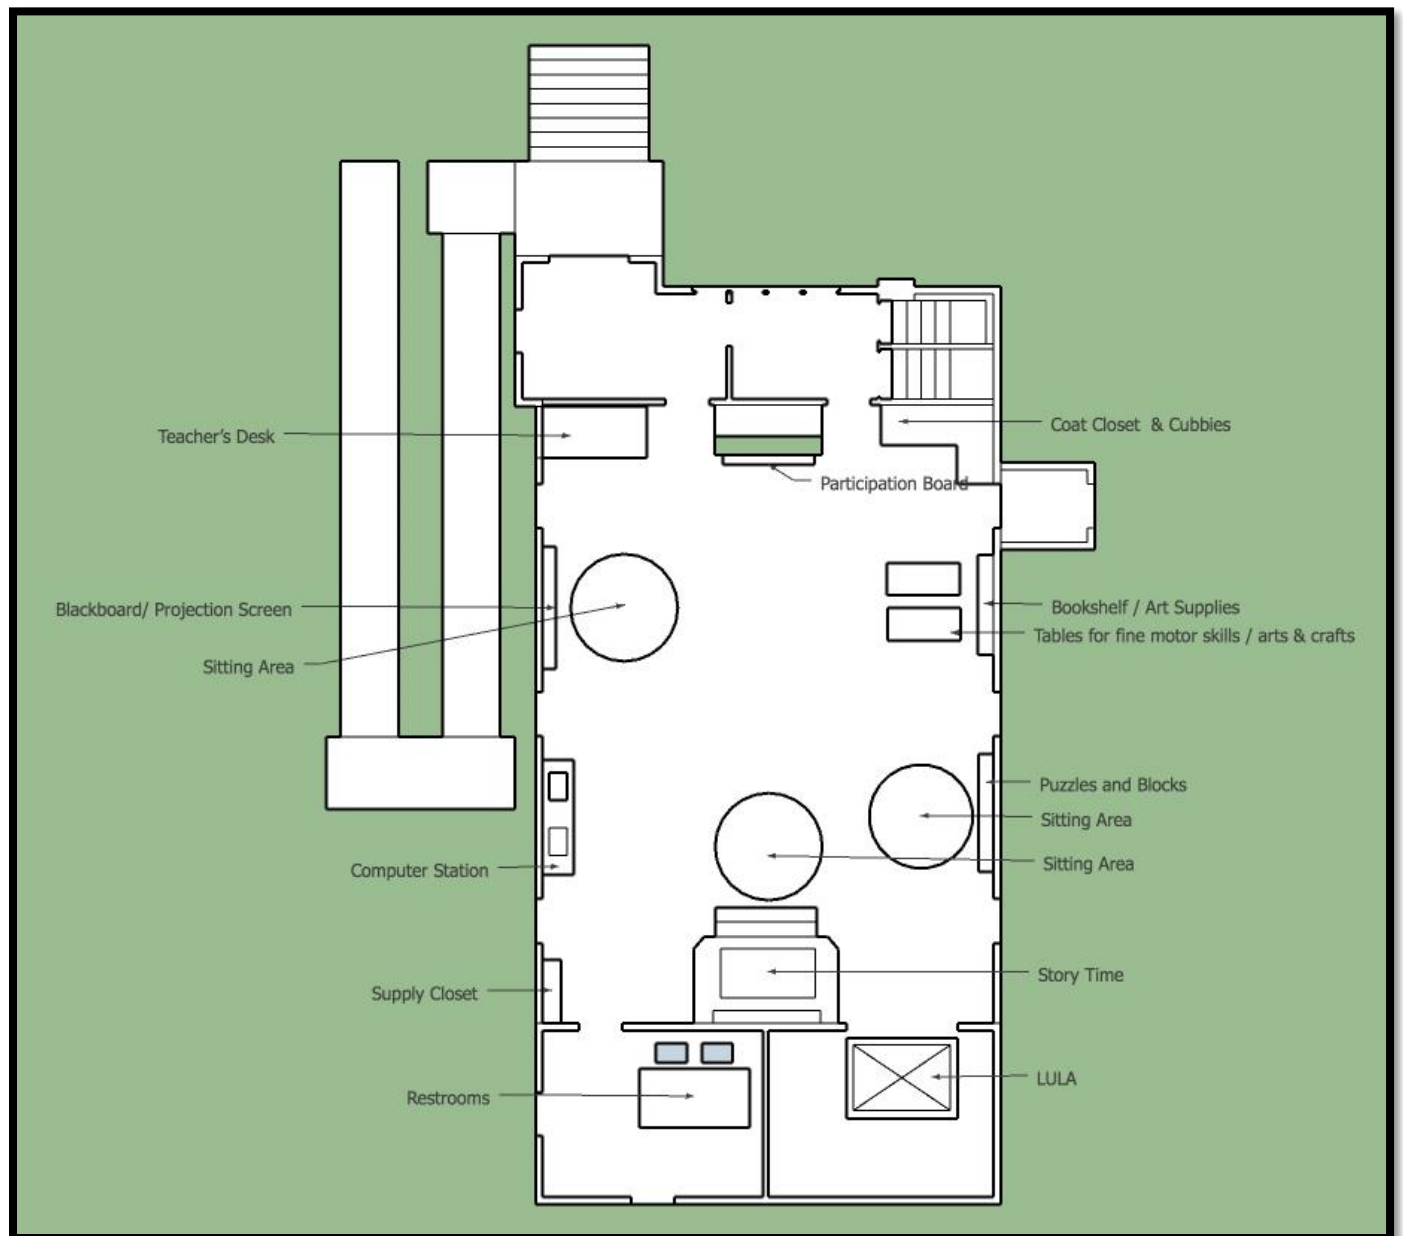
Option 1 – Preschool

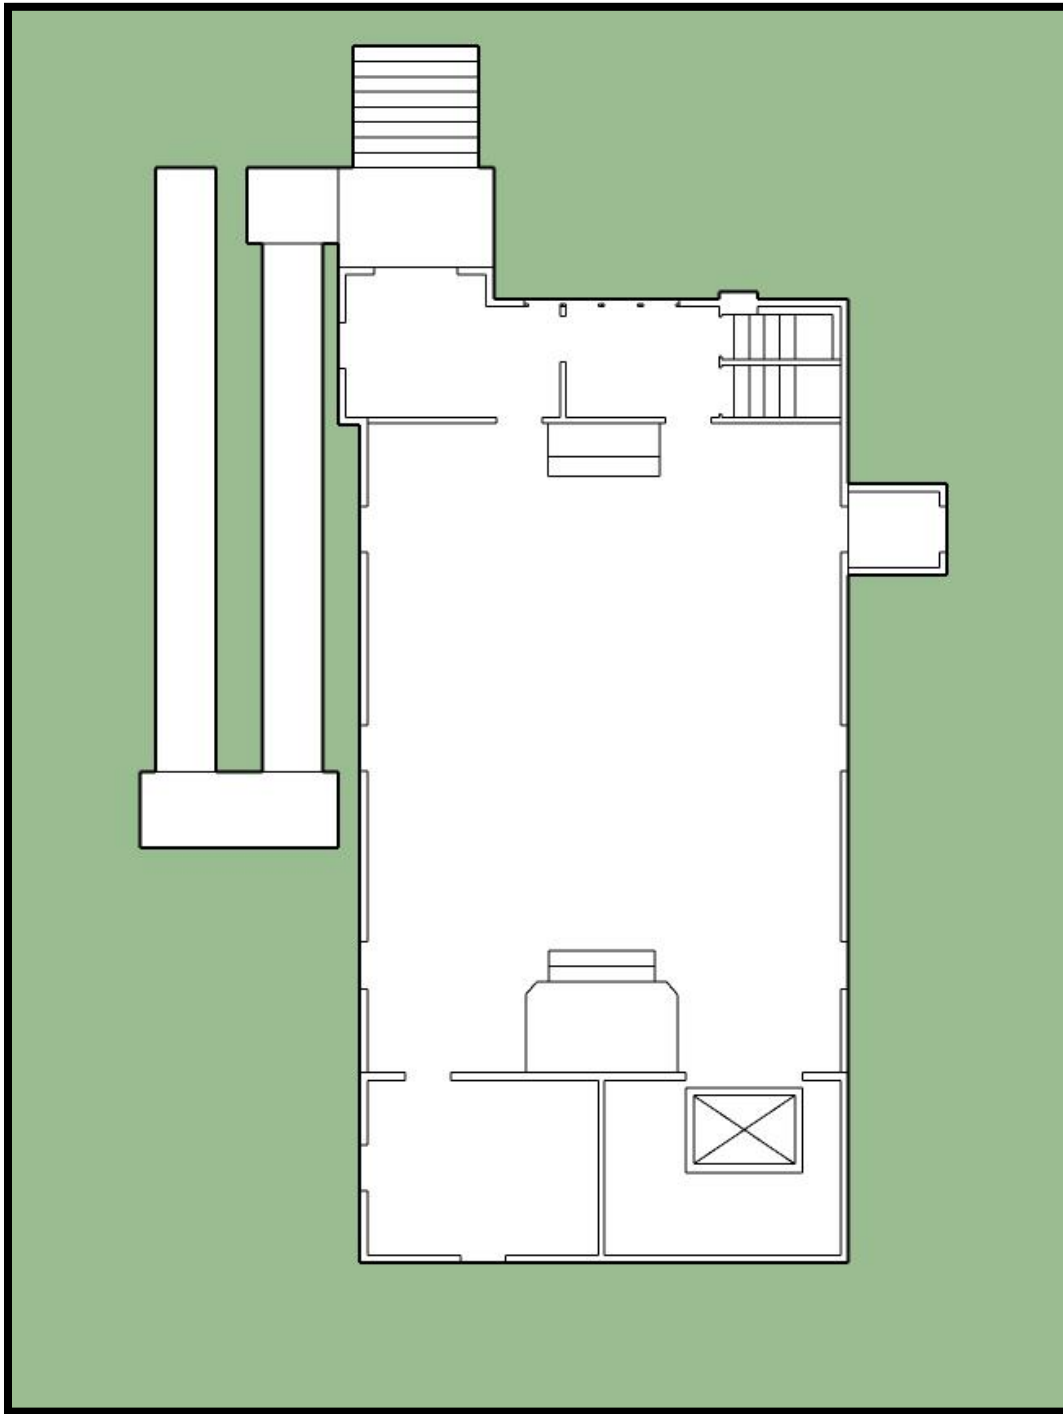
Option 2 – Gathering Space
